#### **a. Email received from ROSPA ahead of play safety report**

Please see below the details of the High Risk Findings, found at the site, School Lane, Hadlow Down:

##### **Asset - Multiplay**

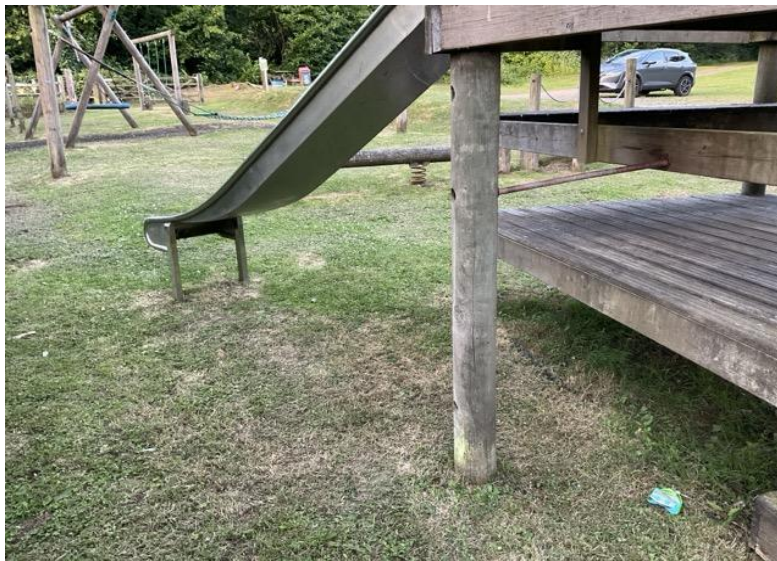
Risk Score: 13 (High)

Name: Timber - decay, Timber is decayed.

Notes: Slides support is decayed. Replace.
