Quarterly/annual risk assessment

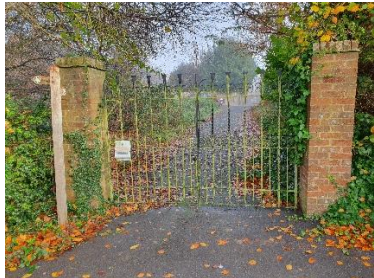
Burial Ground	26 th Nov 2025	<p>Finger posts x2 – adjacent to the perimeter path: The signpost at the entry from School Lane wobbles but should be okay for a while. The signpost by the A272 remains stable but damaged (see photo).</p>	On-going and regular monitoring.
		<p>Gates: All appear to be in reasonable condition.</p>

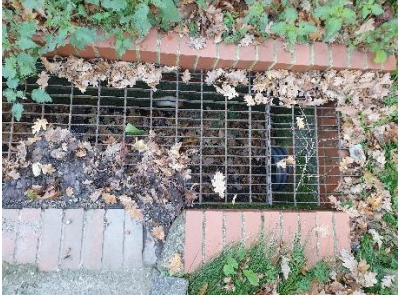
Drainage in Hut Lane	26 th Nov 2025	<p>Drain surrounds and covers are sound. The main drain and smaller drain are both full of 'silt' but this is below the level of the outflow pipes.</p>

Removal of silt and on-going and regular inspection.
-----------------------------	---------------------------	---	--
